**REPORT & RECOMMENDATIONS  
FOR**

**2<sup>ND</sup> DUDES-SNV-JSC JOINT ASSESSMENT**  
for Three Small Towns in Bhutan

Chhukha district – Tsimasham, Tsimalakha and Gedu Towns

**SANITATION AND HYGIENE FOR ALL – SMALL TOWN PROGRAM**

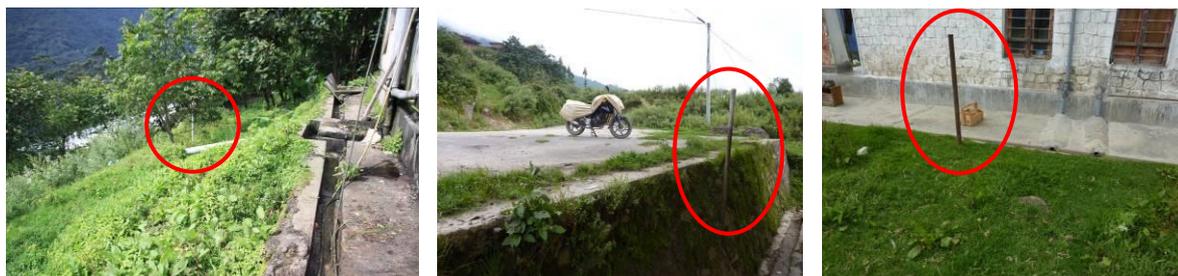
Many of the septic tanks seen in the field could not be checked. Either the structure did not allow any visual inspection (e.g. a parking lot was constructed above one of the septic tanks), or the facilities were at a location difficult to access, sometimes even impossible, due to the steepness of the land or due to the presence of abundant vegetation.

Figure 3: Difficult access to septic tanks

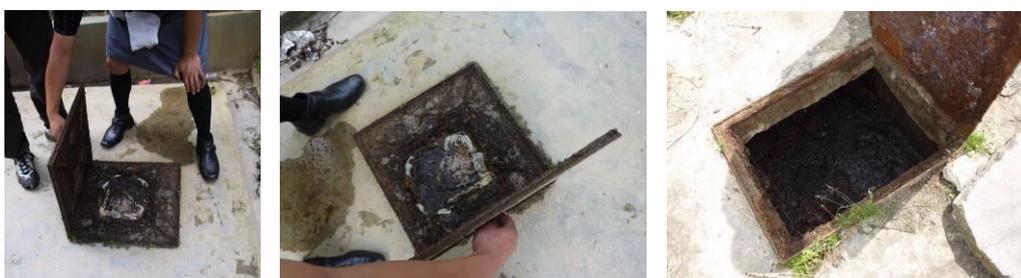
In most of the tanks that could be observed, sludge was accumulated up to the manhole cover level, even, for example, for a house that has been occupied for only six months.

Figure 4: Accumulated sludge in septic tanks

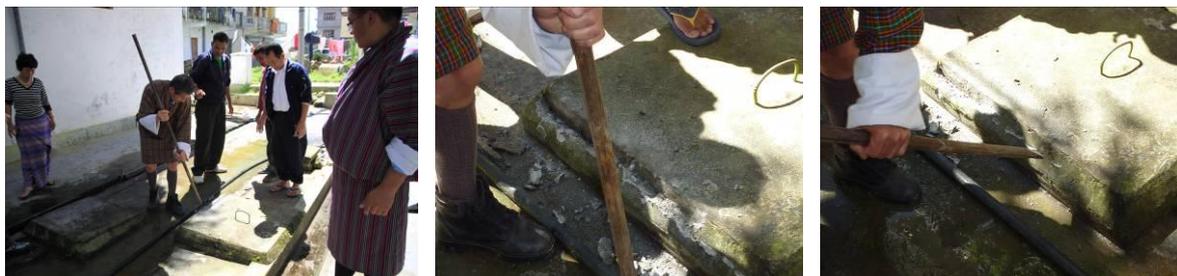
Figure 5: Opening of a sealed septic tank

Among the septic tanks opened and visually checked, one tank stood as an exception. The first compartment did not contain any sludge but a rather high ratio of liquid. It was found out that the sludge did not remain in this compartment and the lay of scum was rather thin. Different reasons could explain this result. Firstly, it has been observed that cistern flush toilets contain a rather high quantity of water (approximately 15 liters). Consequently, this, combined with the small size of the compartments inside the septic tank, prevents sludge from settling in the bottom of the tank and results in sludge being discharged with the effluent. The amount of sludge found in the discharge pipe of this tank, blocked at the time of the inspection, confirmed the theory that part or more of the sludge is discharged with the effluent. In addition, discussions with the householders indicated that toilets are in some cases used to dispose the water used for laundry. Even if it is unclear whether this is a widespread practice or not, this excess of water combined with the small capacity of the

septic tank can potentially increase the phenomenon of sludge not settling inside the compartments. In that case, it would be useful to reduce the quantity of water stored in cistern flush toilets, and to educate communities on the proper usage of water with toilets.

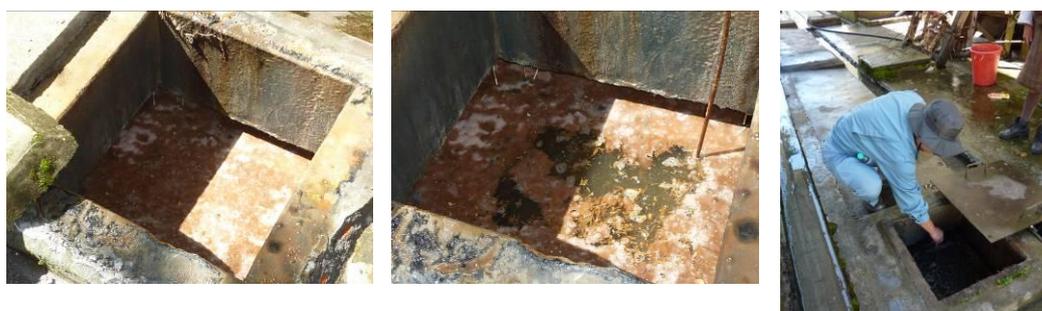
Figure 6: Absence of sludge observed in one septic tank

To reduce the quantity of water flushed into the septic tanks, it is recommendable to reduce the quantity of water stored in cistern flush toilets, for example by putting bottles in the cistern of existing toilets, and by modifying the design of future cisterns. In addition, it would

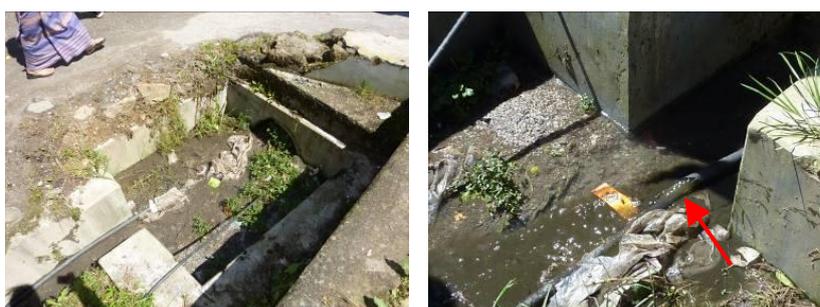
Figure 7: Discharge pipe of septic tank with accumulated sludge (unclogged by the assessment team)

One of the issues found in the field was that it was particularly difficult to locate or see the discharge pipe of the septic tanks, whether they were connected to a leach pit/soak pit or not. In fact, the discharge pipe is very often buried into the ground and impossible to access. This prevents from assessing the discharge effluent and checking water quality, and makes maintenance operations difficult when the discharge pipe is blocked. As for the few discharge pipes that could be inspected visually, the diameter appeared small, which can

potentially lead to regular blockages.

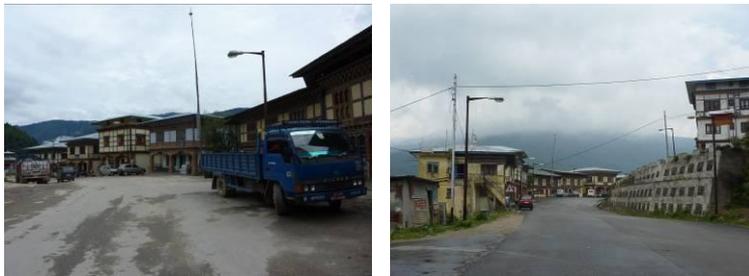
The three towns that were assessed for the programme have different profiles. Due to its strategic location on the highway connecting Thimphu to Phuentsholing, Gedu is a town with many shops and restaurants connected to a septic tank. The same conditions apply to Tsimasham; the lower town of Chhukha (to be officially recognized as a municipality by the parliament of Bhutan in the near future). However, Tsimalakha, the upper town of Chhukha, shows a very different profile with an important number of informal settlements (mainly shops) and households that are not connected to a septic tank or any wastewater treatment system.

Figure 8: Households and shops in Tsimasham

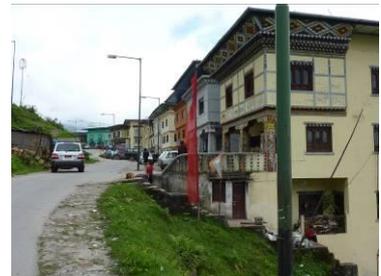
Figure 9: Shops in Gedu

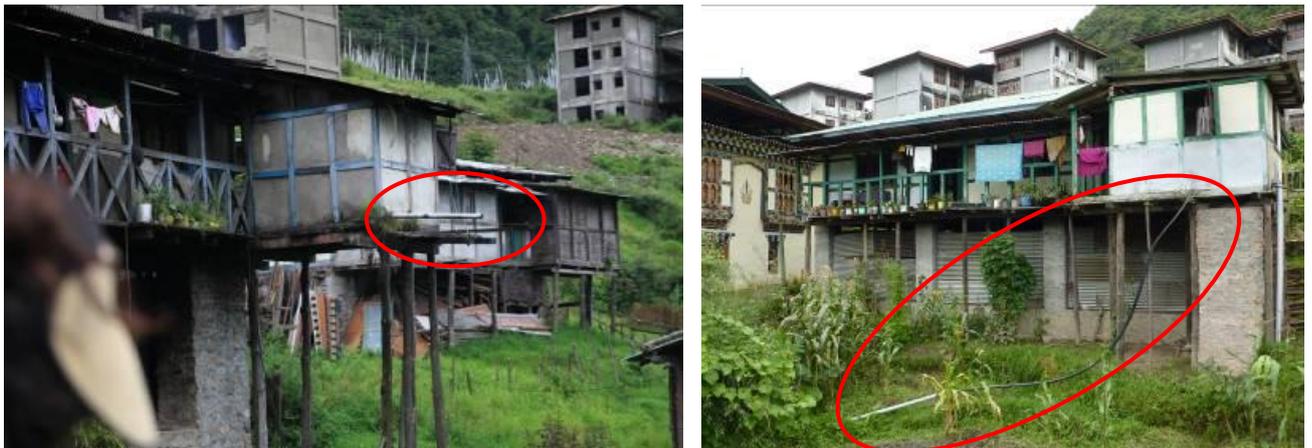
Figure 10: Households in Tsimalakha not connected to a wastewater treatment system

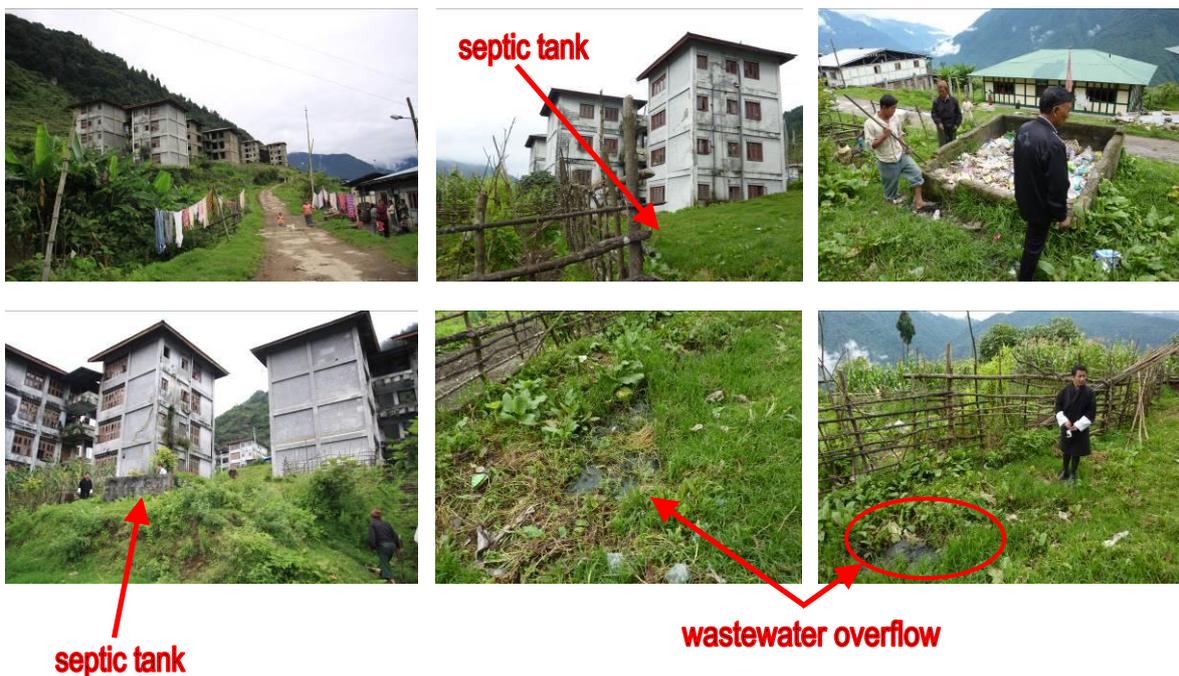
The most worrying areas were found in the BPC colony and the downstream settlements, and a few households closely located to the Chhukha Higher Secondary School. Unsanitary conditions – associating not only wastewater management but also solid waste management – were observed at the BPC colony with buildings connected to overloaded and overflowing septic tanks, or not connected at all (broken connections). This results in untreated wastewater from toilets (black water) being discharged somewhere between the BPC buildings and the settlements at close location downstream (only separated by a road).

Figure 12: Unsanitary conditions at the BPC colony (Tsimalakha)

Another option would be to speed up the relocation of the temporary settlements, some of which are considered illegal, to new development areas with houses connected to a proper wastewater treatment system. For the BPC colony, the Chhukha district authorities emitted the desire to call a meeting with the BPC authorities to describe the actual problems and ask them to repair the broken septic tanks of the colony.

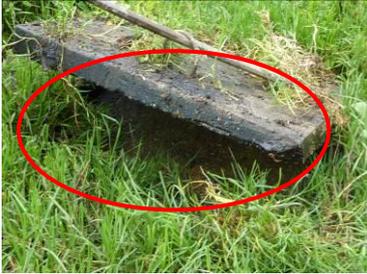
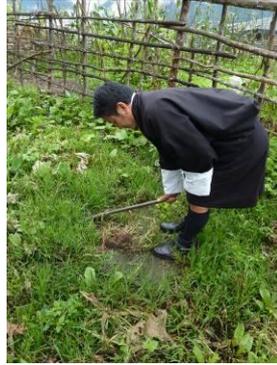
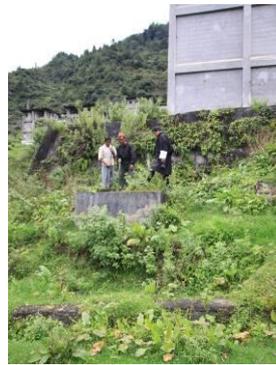
Figure 13: Opening of septic tanks in Tsimalakha (BPC colony)

Figure 14: Overload of sludge in septic tank

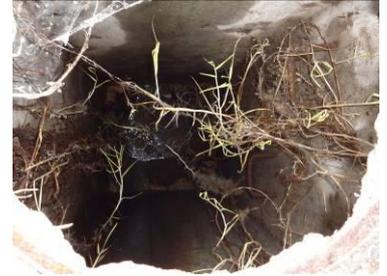
Figure 15: Empty septic tank

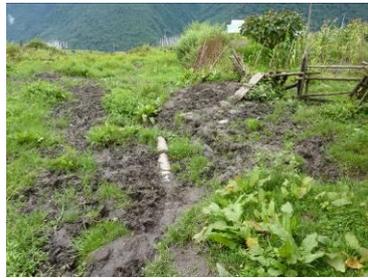
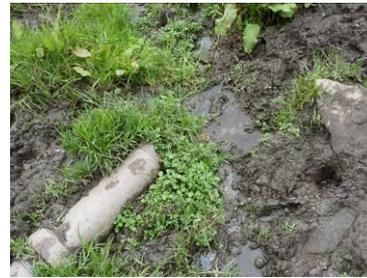
Figure 16: Broken connection between a BPC building to a septic tank downstream

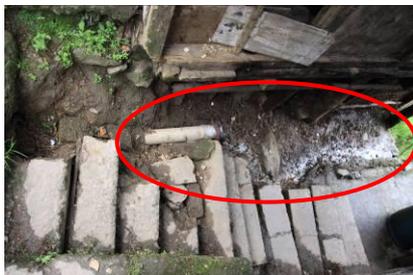
In some areas of Tsimalakha, grey water flowing from the BPC colony was also found passing next to few households located downstream, adding health threats to this hazardous situation (it has been indicated to our team that this area is where most of the diarrhea cases are accounted in Chhukha).

Figure 17: Passage of grey water from the BPC colony through downstream settlements

To avoid the accumulation or inappropriate passage of grey water nearby houses, it is important to check all open drains and repair/improve the system where needed. Regular cleaning is also crucial to ensure that garbage does not block the drains.

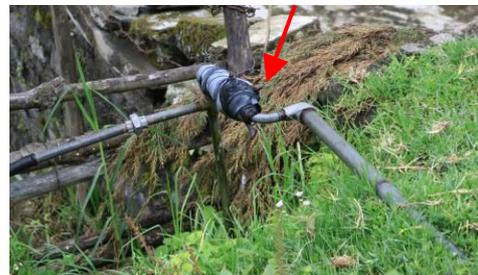
Figure 18: Repair of leak in water supply pipe

To prevent water contamination through leaking pipes, it is also advisable to promote the repair of water supply pipes.

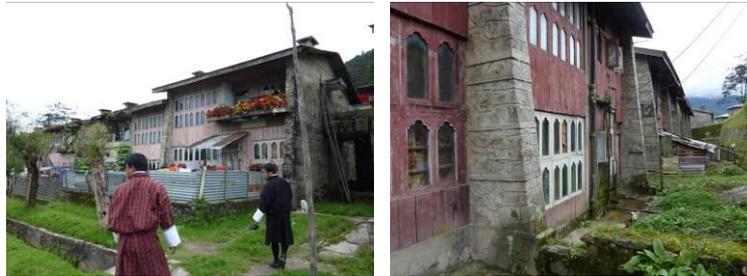
A few houses located upstream of the Chhukha Higher Secondary School also were of concern, as none of these were connected to a wastewater treatment system and were having untreated wastewater infiltrating the ground despite close vicinity to the school. This is a serious public health problem that could have a significant impact on students' health, as

the water supply network passing in this area can get contaminated if water pipes leak.

Figure 19: Houses without septic tanks upstream Chhukha Higher Secondary School

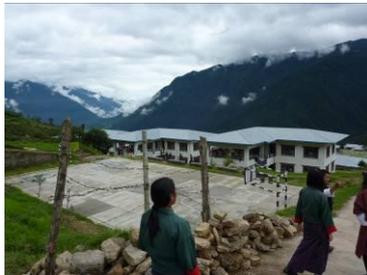
Figure 20: Chhukha Higher Secondary School

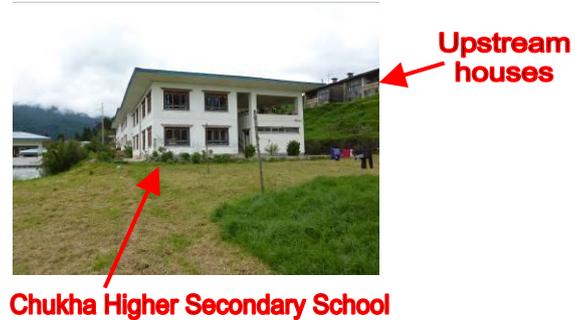
Figure 21: Distance between upstream houses and Chhukha Higher Secondary School

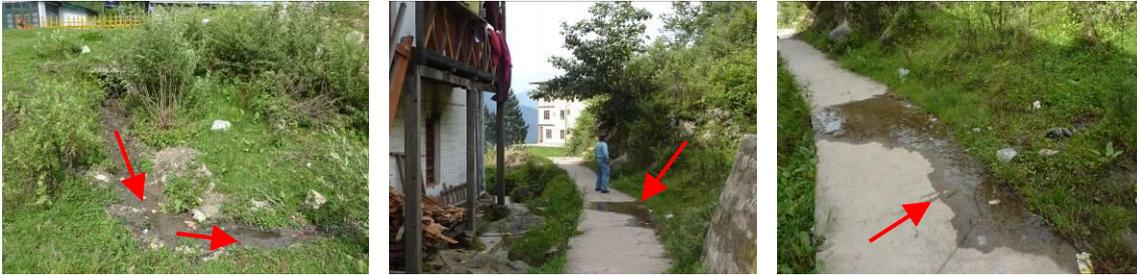
It has been observed in some areas of Tsimasham and Tsimalakha that, due to faulty drains, grey water was sometimes passing through the garden of houses or stagnating next to few households located downstream. For example, and as explained previously, grey water regularly flows across a few shop keepers' houses located downstream the BPC colony. This is naturally a potential health threat to the populations living nearby, especially children. Consequently, drains in the three targeted towns of the programme need to be thoroughly checked to ensure that grey water is properly collected and drained, as well as stormwater

during rainfall events.

**Figure 22:** Improper drainage of grey water

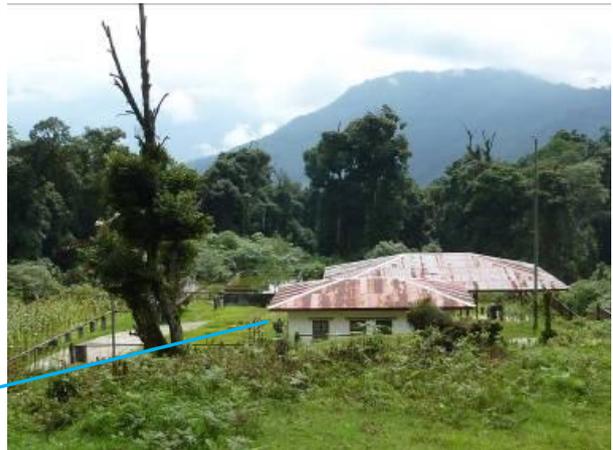
**Figure 23:** View of the sewage treatment plant

The sewage treatment plant of Gedu was implemented to serve the buildings built for the Tala Hydropower Project infrastructure. Currently, this system covers the student accommodations, the hospital of Gedu and the Gedu College of Commerce and Business Studies. This plant is not a municipal property and has been handed over to the Gedu College when the organization in charge of the Tala Hydropower Project stopped managing this facility and its associated sewer network.

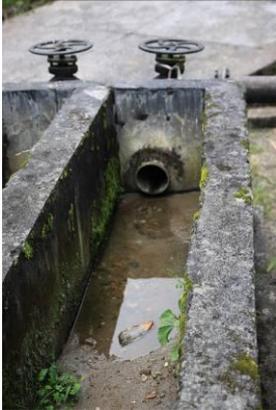
Figure 24: Inlet of the sewage treatment plant

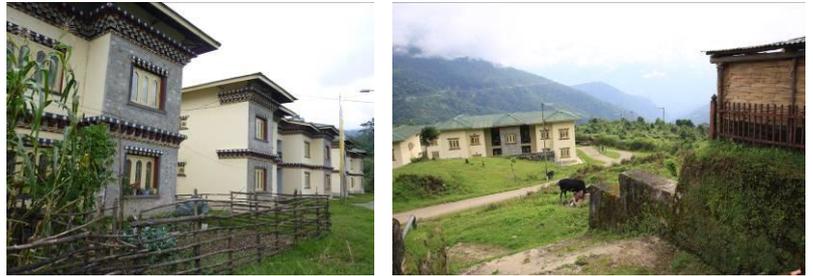
Figure 25: Student accommodations in Gedu (connected to the sewage treatment plant)

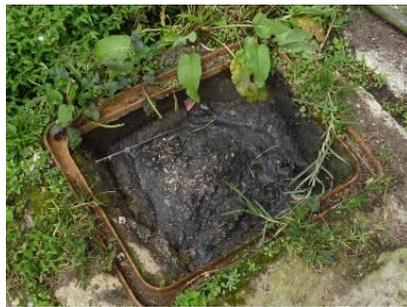
Figure 26: Accumulation of toilet waste due to blocked sewer pipes

While the current number of users is unclear and will need to be further assessed (probably much more than 1,000 users as the College itself gathers 1,500 students), wastewater is presently not reaching the plant. Although a detailed assessment of the sewer network will be needed to identify why wastewater is not conveyed to the plant and where it goes, a discussion with local communities indicated that some of the inspection chambers of the

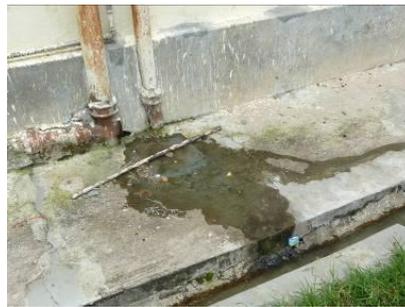
Figure 27: Grey water overflowing from inlet

uniform flow conditions. Depending on the time of the day, wastewater volume differs. To ensure a regular flow of wastewater and a stable treatment even during flow peaks, it would be beneficial to install a flow equalization tank prior to the preliminary stage of treatment. This tank equipped with a pump would be used for temporary storage. When the volume of wastewater reaches a certain level in the tank, wastewater will be lifted by the pump and sent to the plant for treatment.

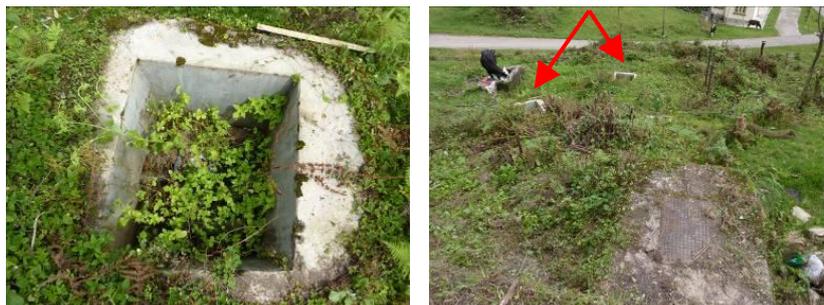
Figure 28: Sewer inspection chambers blocked due to the absence of maintenance

sewer network were blocked with garbage. These inspection chambers were previously maintained by the staffs of the Tala Hydropower Project but nobody has continued this work since they left (about two years ago). A visual check of one of the inspection chambers confirmed this statement. In addition, a visit to student accommodations also showed that sewer pipes were blocked, as toilet wastewater was accumulating in the sewer outlet next to the building. It is urgent to find where goes the wastewater of the buildings connected to the sewage treatment plant, as this poses a serious health threat to the population. It is crucial to thoroughly assess the sewer network to evaluate the state of the pipes, identify and repair damaged pipes, if any.

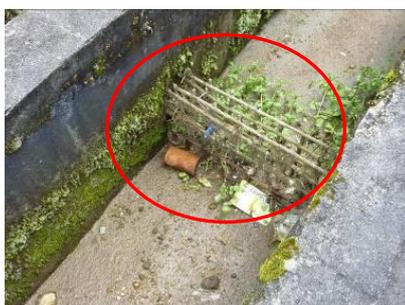
Figure 30: Actual screening system at the sewage treatment plant

2. Screen improvement: it would be beneficial to improve the screens at the preliminary stage of treatment to improve the removal of large objects and to optimize solid removal. This would prevent damage further in the plant and improve the efficiency of the treatment process.

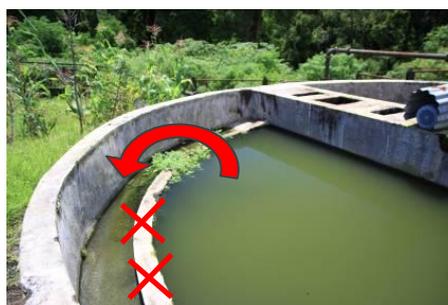
Figure 31: Irregular flow removal at the periphery of the sedimentation tank

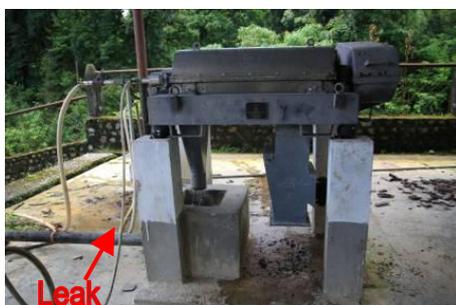
Figure 32: Maintenance issue with the dewatering machine

5. Improvement of dewatering process: dewatering process could be eased by mixing

sludge to a coagulant inside a tank to be added between the sedimentation tank and the dewatering machine. Finally, one of the pipes of the dewatering machine was leaking at the time of the visit and needs to be replaced.

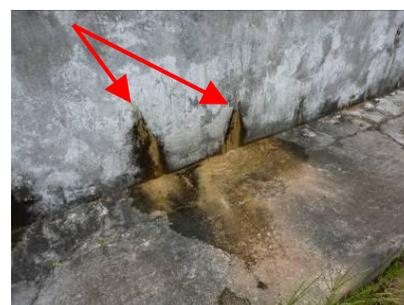
Figure 33: Cracks in the structure of one oxidation ditch

3. Oxidation ditch improvement and repair: to allow the rotor of the final oxidation ditch to be sufficiently in contact with wastewater, it will be necessary to either lower the rotor or raise the outlet pipe. The cracks visible in the structure of the same oxidation ditch will also need to be repaired.

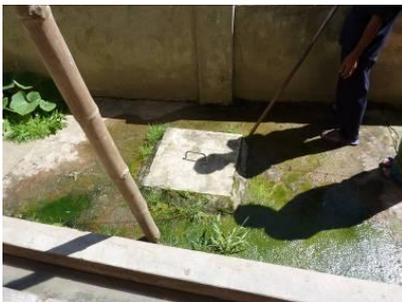
Figure 35: Septic tank before desludging operation in Thimphu (visible wastewater overflow)

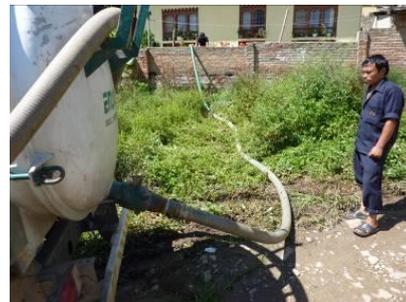
Figure 36: Desludging operation

For a cesspool truck, two or three trips are usually needed to empty the septic tank of individual households (bungalow type), and five or six trips for buildings. On average, about fifty trips are conducted each month. For our team, following the desludging operation of one building proved to be an instructive experience. If the number of operators present for this work was quite sufficient (three operators in addition to the driver), their equipment was less satisfying. Despite wearing a uniform, operators did not wear work shoes, gloves or other safety equipments (only one operator was wearing a mask). Although three trips were made, desludging operations went quite smoothly. However, it is regrettable that the desludging service compulsory with the sewer user charge paid monthly (without extra charge if done once a year) is only limited to three trips. For the observed building, three trips were not enough to empty the septic tank and, as the building owner was not willing to pay for an extra trip, the tank was left partly filled. Furthermore, what remained in the tank was the most solid portion of sludge, which is also the most contaminated one. By training operators, pumping technique could improve and sludge could be collected more effectively. After collection, sludge was discharged in a manhole of the sewer network located nearby the visited building. This operation did not cause any issue. Nevertheless, for safety reason with road traffic, one operator could stay on-site during the duration of the discharge operations, as the manhole cover remained open and one pipe used for sludge dumping also was left on the street.

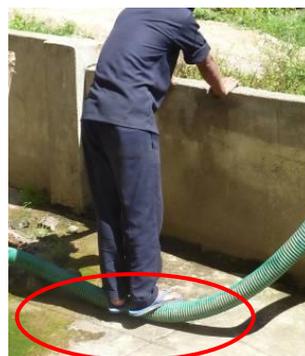
Figure 37: Improper equipment (shoes) during desludging operation

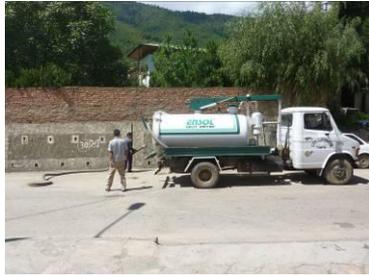
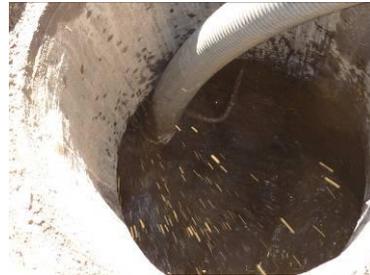
Figure 38: Discharge of collected sludge in a sewer manhole

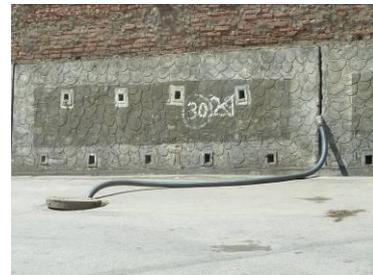
Figure 39: Potential danger with traffic after discharge operations

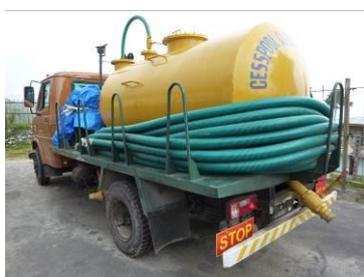
Figure 40: Cesspool truck recently acquired for desludging operations in Tsimasham/Tsimalakha

To manage sludge in an environmentally safe manner, regular sludge collection, transport and treatment need to be organized. To collect and transport sludge, Tsimasham/Tsimalakha towns have recently acquired a cesspool truck, which has not been utilized yet but is ready for use. Except in Phuentsholing, this is the only vehicle available to collect and transport sludge in the Chhukha district (Gedu has no cesspool truck at disposal). Few options for sludge collection and disposal have been discussed with local authorities. This consultation considered the use of the existing cesspool truck to cover both Tsimasham/Tsimalakha and Gedu. However, we would not recommend this option, as the transport from Tsimasham/Tsimalakha to Gedu would consume too much time, be expensive and uncertain due to road conditions, for instance, during the monsoon season. It is preferable to acquire a new cesspool truck for Gedu or reassign the truck for certain months. In addition, to improve the service quality and enable regular desludging, another

vehicle in both Tshimasham/Tsimalakha and Gedu might be needed, depending on sludge collection frequency to cover all the towns, the number of trips needed to empty each tank, and the total volume of sludge to treat, dispose or reuse.

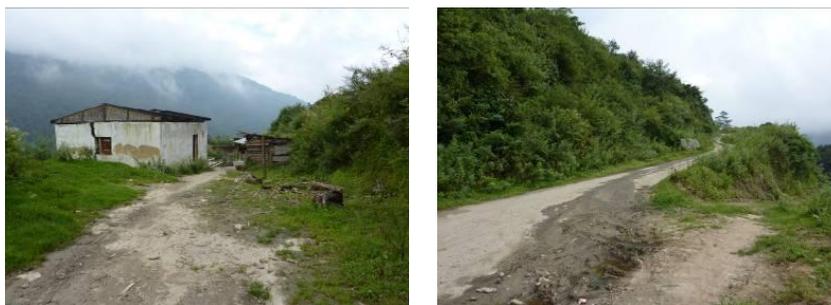
Municipal staff for O&M would also need to be recruited and trained. To implement such facility, land would be needed. A possible location has been found below Tsimasham called the 'Old Dog Pond Site', already accessible by road and having enough space for receiving such facility; space that can even be enlarged if needed.

Figure 41: Potential sludge disposal site in Tsimasham ('Old Dog Pond Site')

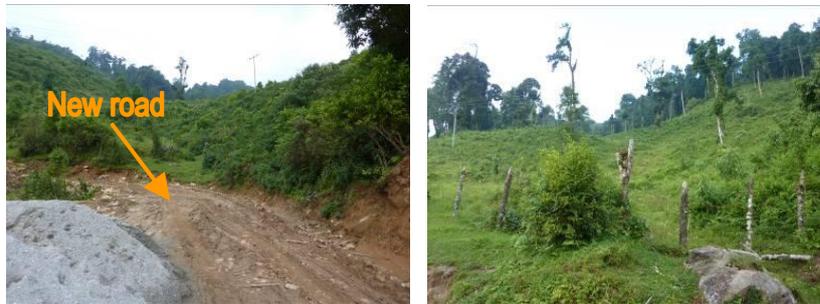
As the sewage treatment plant in Gedu would need some maintenance and repair in order to function properly, the option 3 can be used as a temporary measure until the plant is ready for operation. A favorable location for the disposal site was identified downstream to the plant where no settlement is constructed yet. However, the construction of a new road indicated that new settlements might be built in this area. Therefore, if this disposal site option is considered, further consultation will be required to confirm if this area is appropriate for sludge disposal or if it is necessary to identify another site further away from the town.

Figure 42: Potential sludge disposal site in Gedu (to be confirmed)

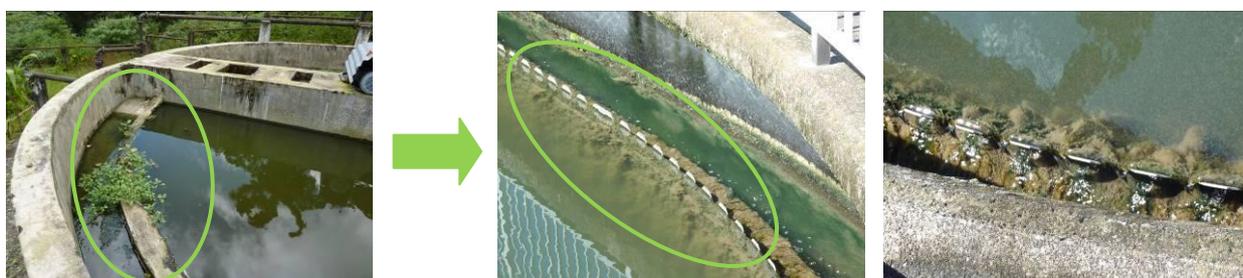
Figure 43: Appropriate outlet zone for uniform flow removal in the sedimentation tank
